EFFECT OF SULFUR IN JP-5 FUEL ON HOT CORROSION OF COATED SUPERALLOYS IN MARINE ENVIRONMENT

FINAL SUMMARY REPORT
APRIL 1, 1967 TO MARCH 31, 1968

BY
H. T. QUIGG AND R. M. SCHIRMER

PHILLIPS PETROLEUM COMPANY - RESEARCH DIVISION REPORT 5058-68R

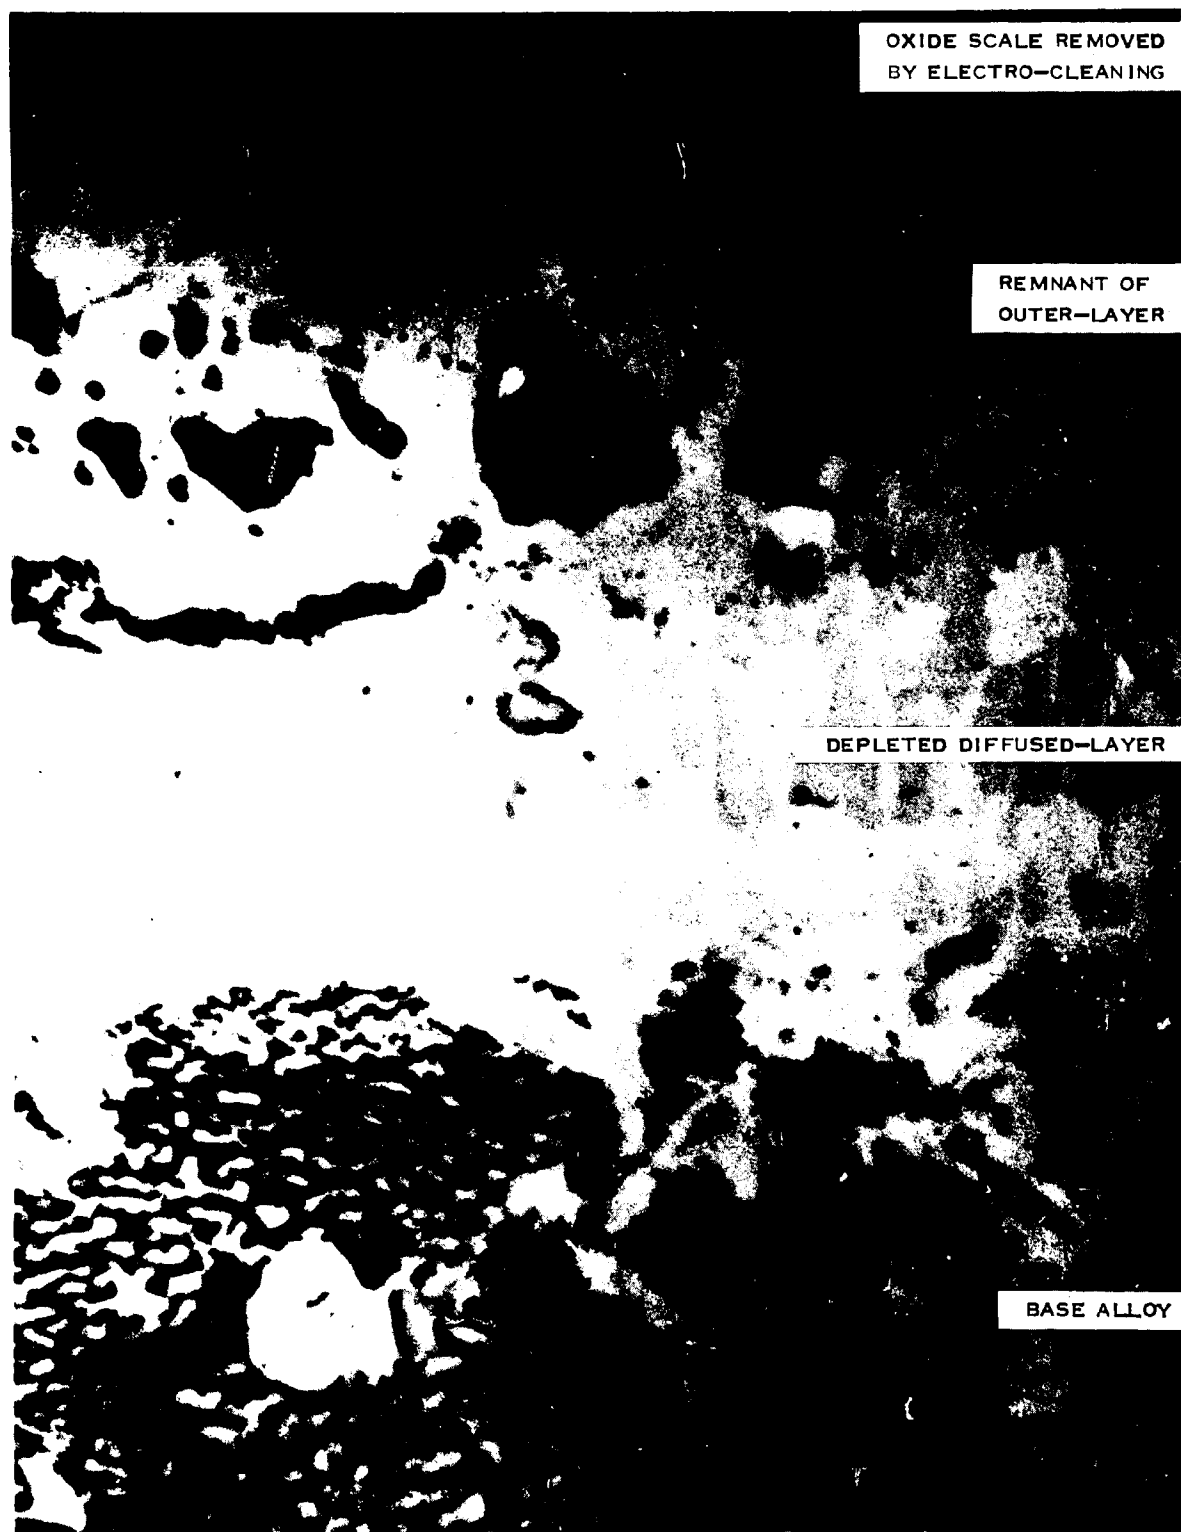
FIGURE 20
DEPLETION OF MISCO MDC-1 COATING ON MAR M-200 SPECIMEN

METALLOGRAPHIC CROSS-SECTION OF SPECIMEN AFTER 50 HOURS AT 2000 F TEST CONDITION
WITH NO SEA SALT IN AIR AND <0.0040 WT % SULFUR IN FUEL.
3% SULFURIC ACID-ELECTROLYTIC ETCHED. 2000X MAGNIFICATION.

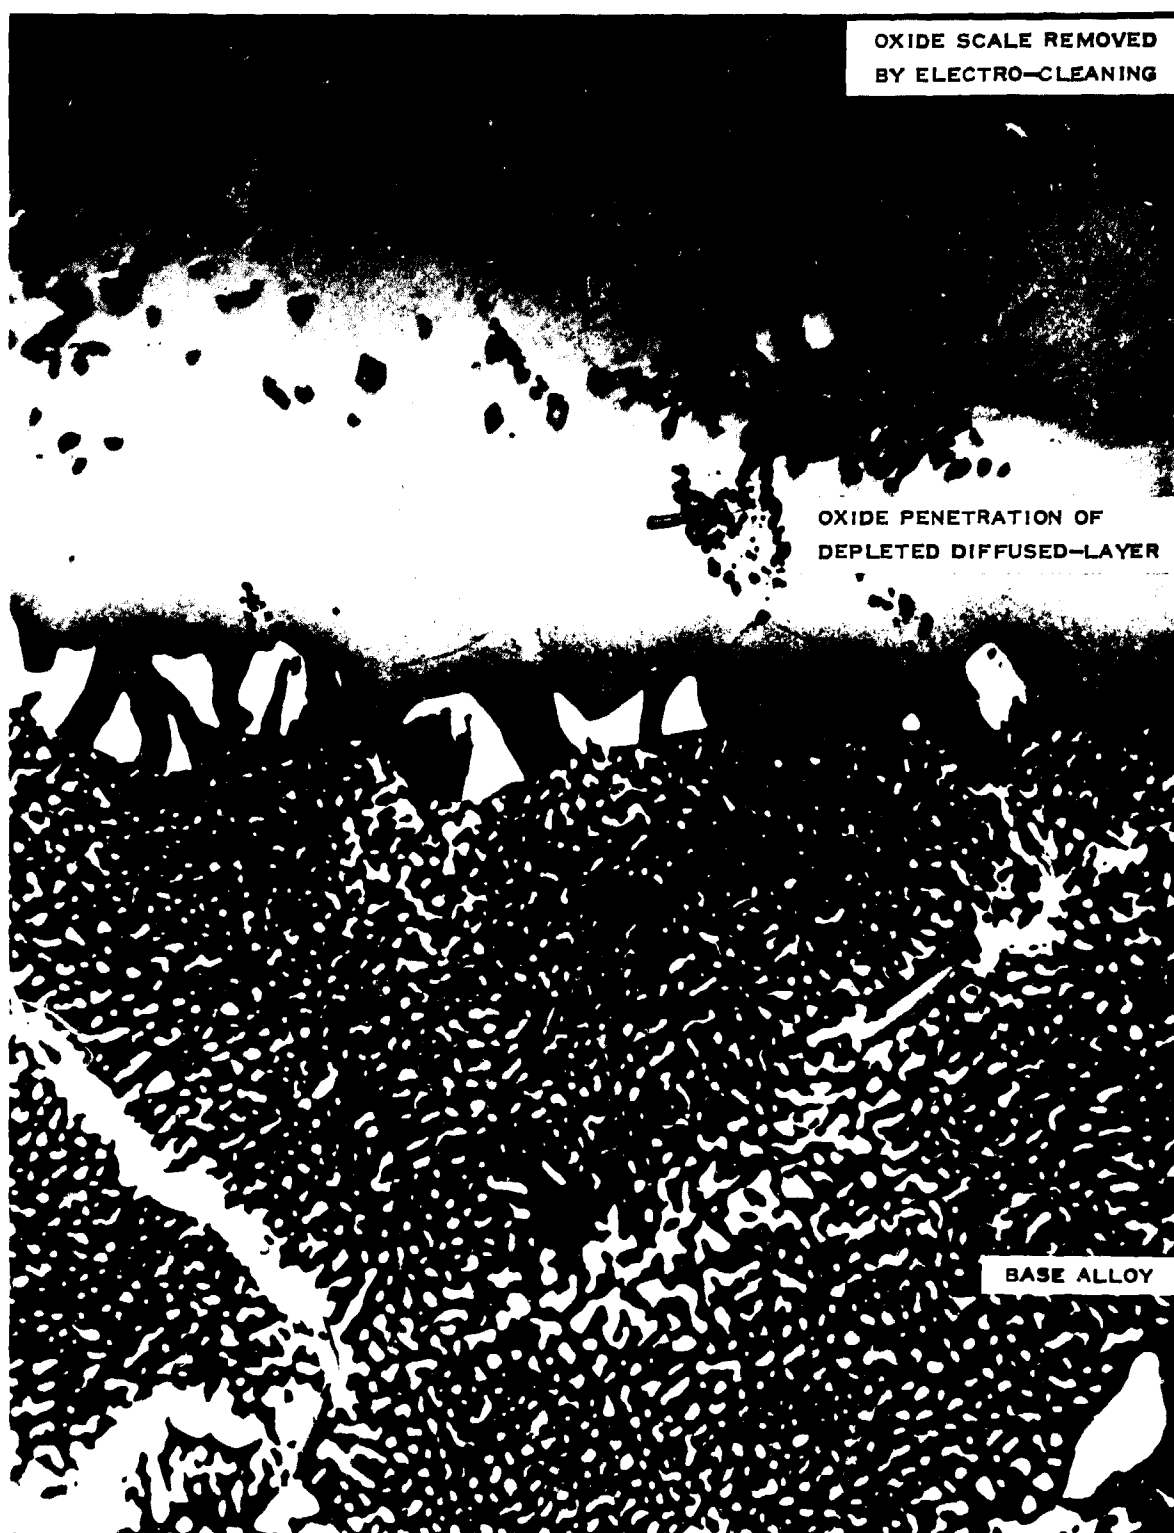
FIGURE 21
OXIDATION OF MISCO MDC-1 COATING ON MAR M-200 SPECIMEN

METALLOGRAPHIC CROSS-SECTION OF SPECIMEN AFTER 45 HOURS AT 2000 F TEST CONDITION
WITH NO SEA SALT IN AIR AND 0.40 WT % SULFUR IN FUEL.
3% SULFURIC ACID-ELECTROLYTIC ETCHED. 2000X MAGNIFICATION.

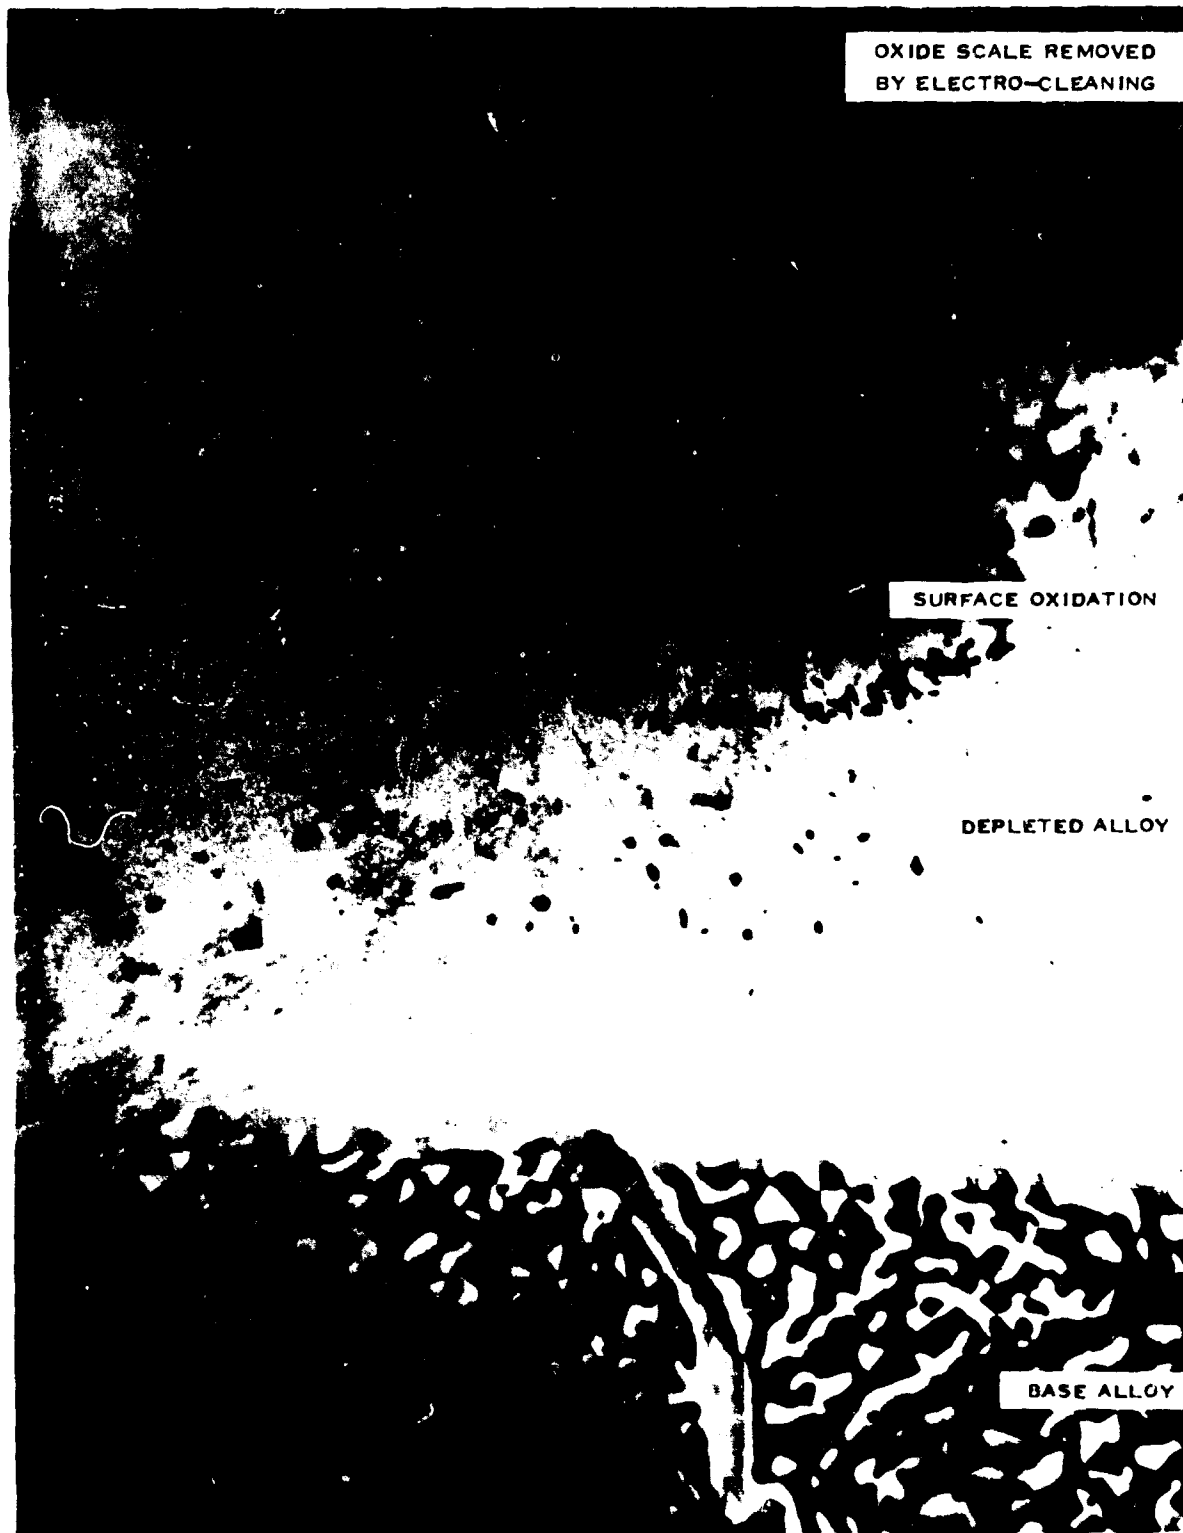
FIGURE 22
OXIDATION OF MISCO MDC-1 COATED MAR M-200 SPECIMEN

METALLOGRAPHIC CROSS-SECTION OF SPECIMEN AFTER 50 HOURS AT 2000 F TEST CONDITION
WITH NO SEA SALT IN AIR AND 0.40 WT % SULFUR IN FUEL.
3% SULFURIC ACID-ELECTROLYTIC ETCHED. 2000X MAGNIFICATION.

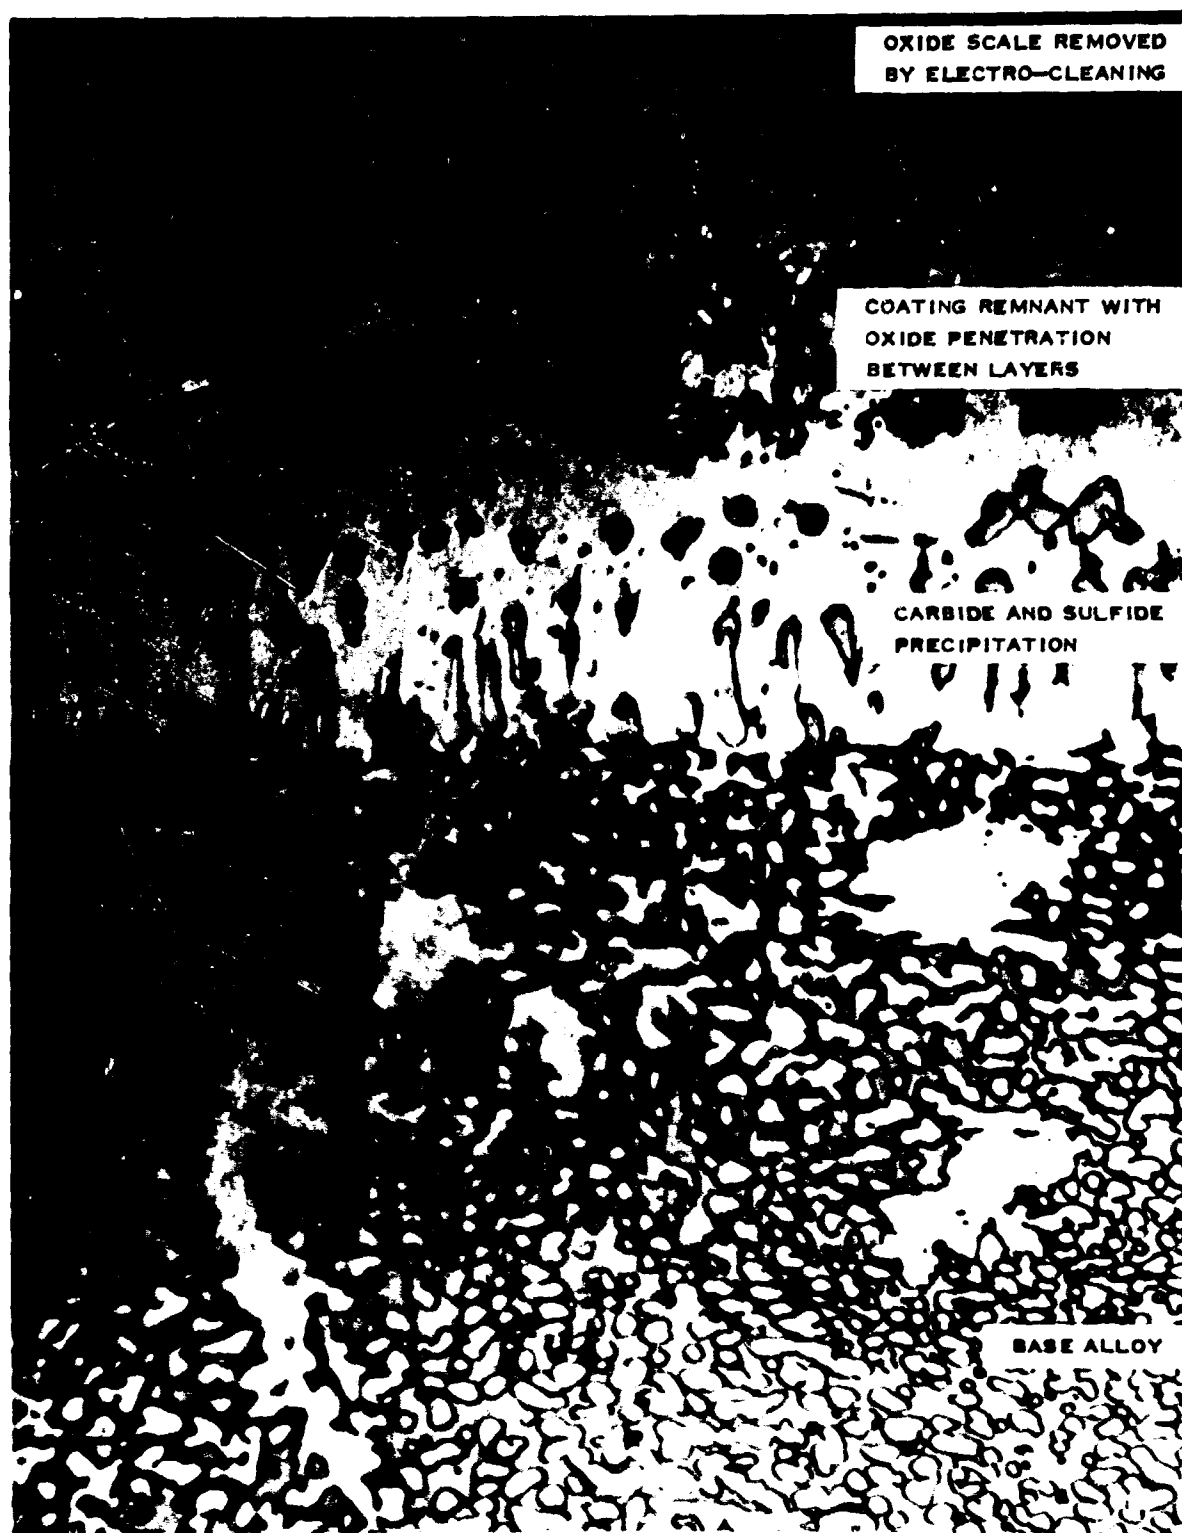
FIGURE 23
OXIDATION OF MISCO MDC-1 COATING ON MAR M-200 SPECIMEN

METALLOGRAPHIC CROSS-SECTION OF SPECIMEN AFTER 50 HOURS AT 2000 F TEST CONDITION
WITH 1 PPM SEA SALT IN AIR AND <0.0040 WT % SULFUR IN FUEL.
3% SULFURIC ACID-ELECTROLYTIC ETCHED. 2000X MAGNIFICATION.

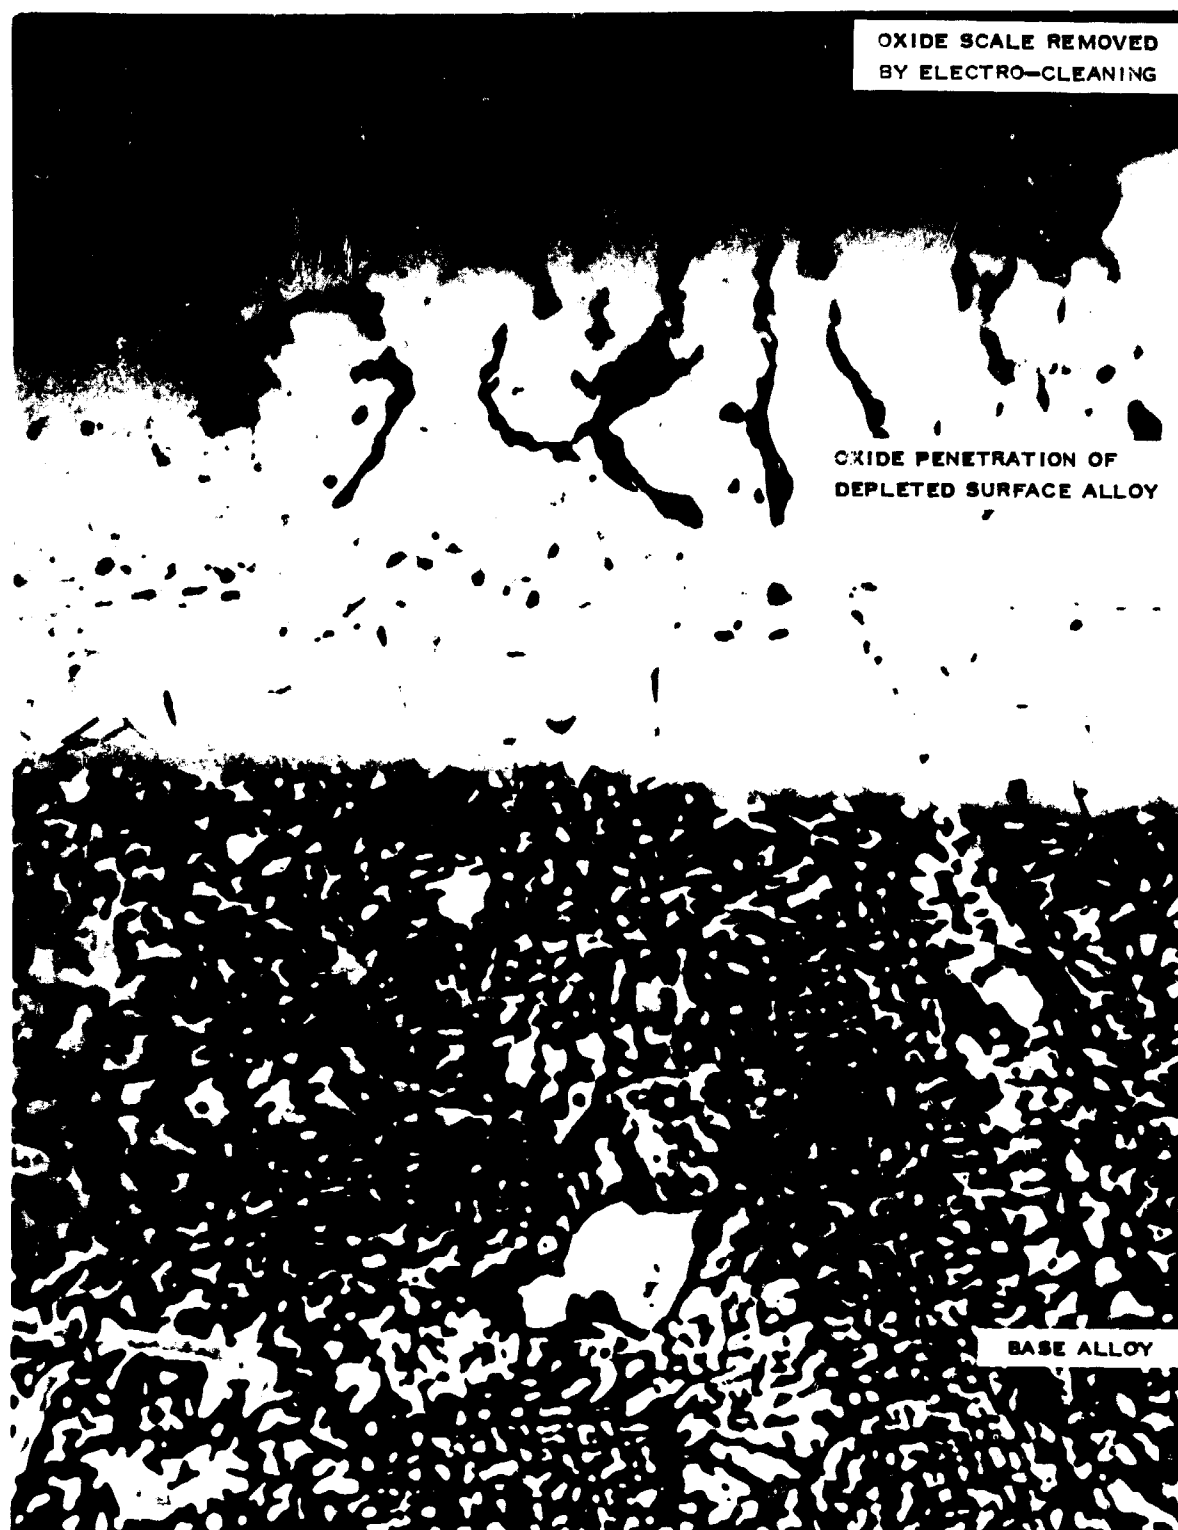
FIGURE 24
OXIDATION OF MISCO MDC-1 COATED MAR M-200 SPECIMEN

METALLOGRAPHIC CROSS-SECTION OF SPECIMEN AFTER 45 HOURS AT 2000 F TEST CONDITION
WITH 1 PPM SEA SALT IN AIR AND 0.40 WT % SULFUR IN FUEL,
3% SULFUR ACID-ELECTROLYTIC ETCHED. 2000X MAGNIFICATION.

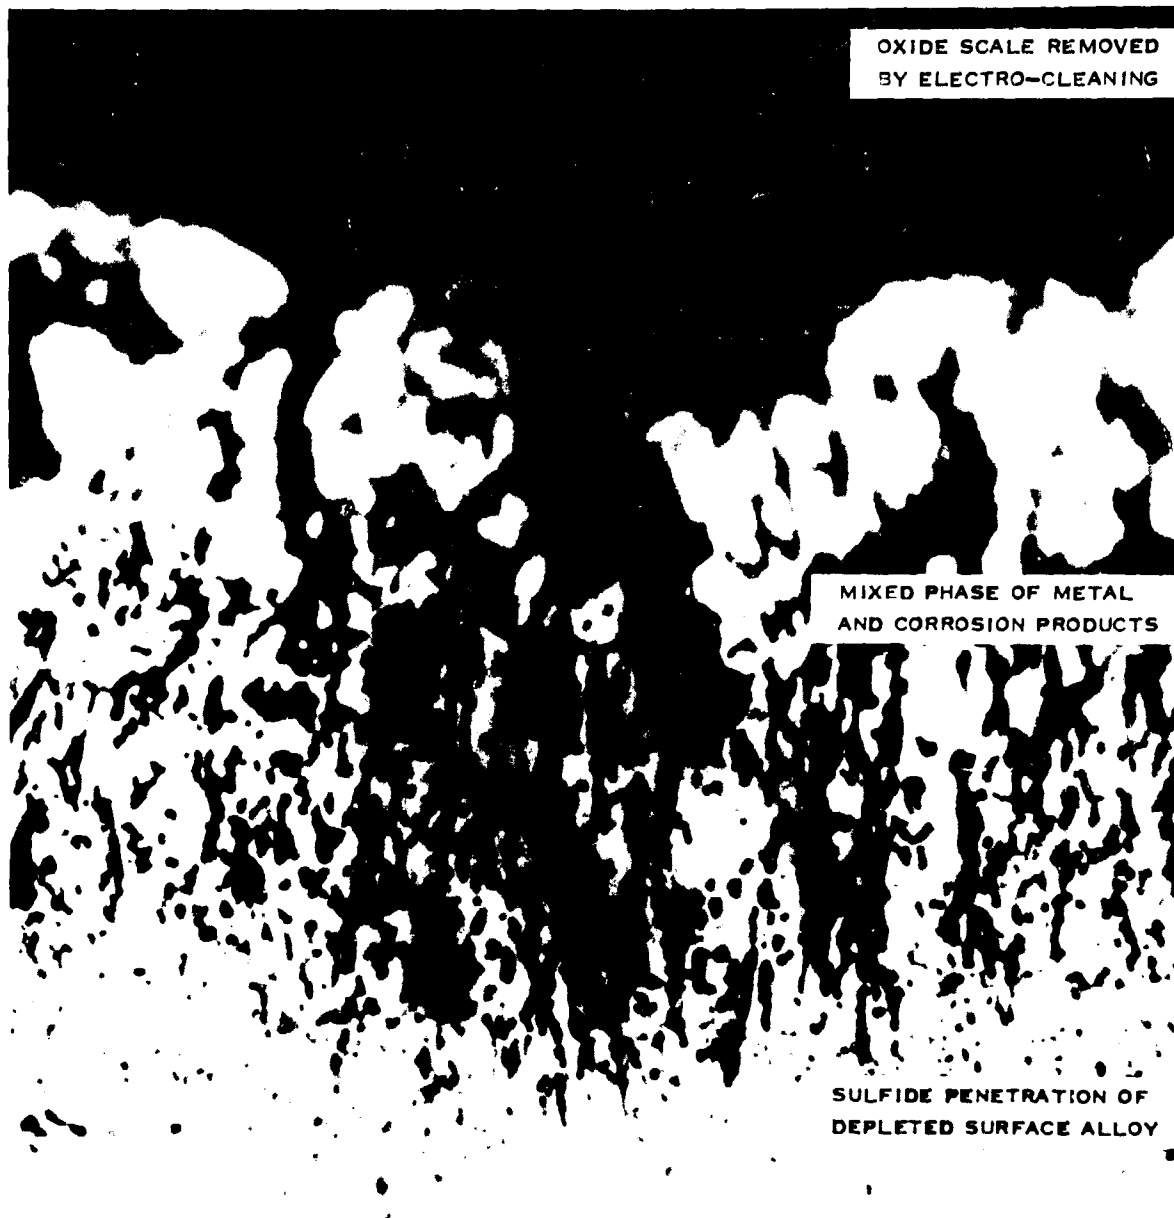
FIGURE 25
ACCELERATED OXIDATION OF MISCO MDC-1 COATED MAR M-200 SPECIMEN

METALLOGRAPHIC CROSS-SECTION OF SPECIMEN AFTER 25 HOURS AT 2000 F TEST CONDITION
WITH 1 PPM SEA SALT IN AIR AND 0.40 WT % SULFUR IN FUEL.
3000X MAGNIFICATION.

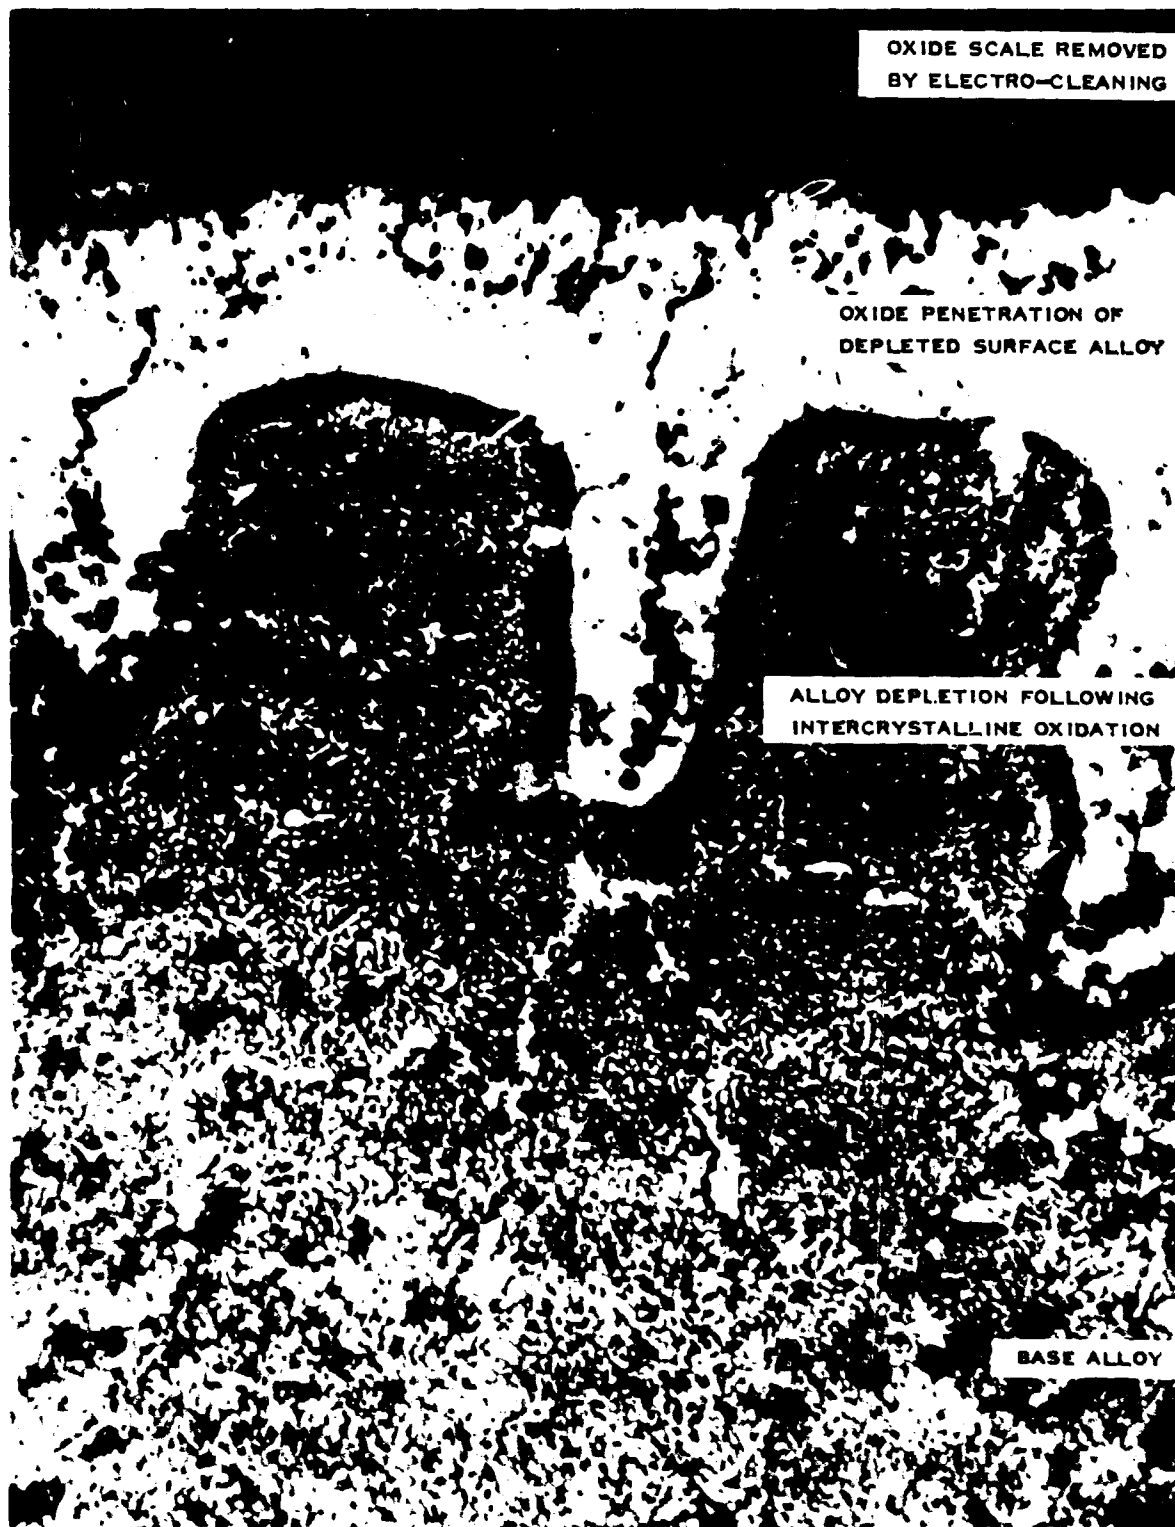
FIGURE 26

Limited evidence of intercrystalline oxidation, to a depth of up to 8 mils, was found in a few specimens at the point of flexure from support by the holder, as shown in Figure 26. This photomicrograph is presented to illustrate the type of attack which would vitiate the use of loss in weight by the specimens as a measure of metal damage. However, such intercrystalline corrosion was not found to be extensive enough under the conditions of our investigation to be of practical importance.

METALLOGRAPHIC CROSS-SECTION OF SPECIMEN AFTER 45 HOURS AT 2000 F TEST CONDITION
WITH 1 PPM SEA SALT IN AIR AND 0.4 WT % SULFUR IN FUEL.
3% SULFURIC ACID-ELECTROLYTIC ETCHED. 500X MAGNIFICATION.

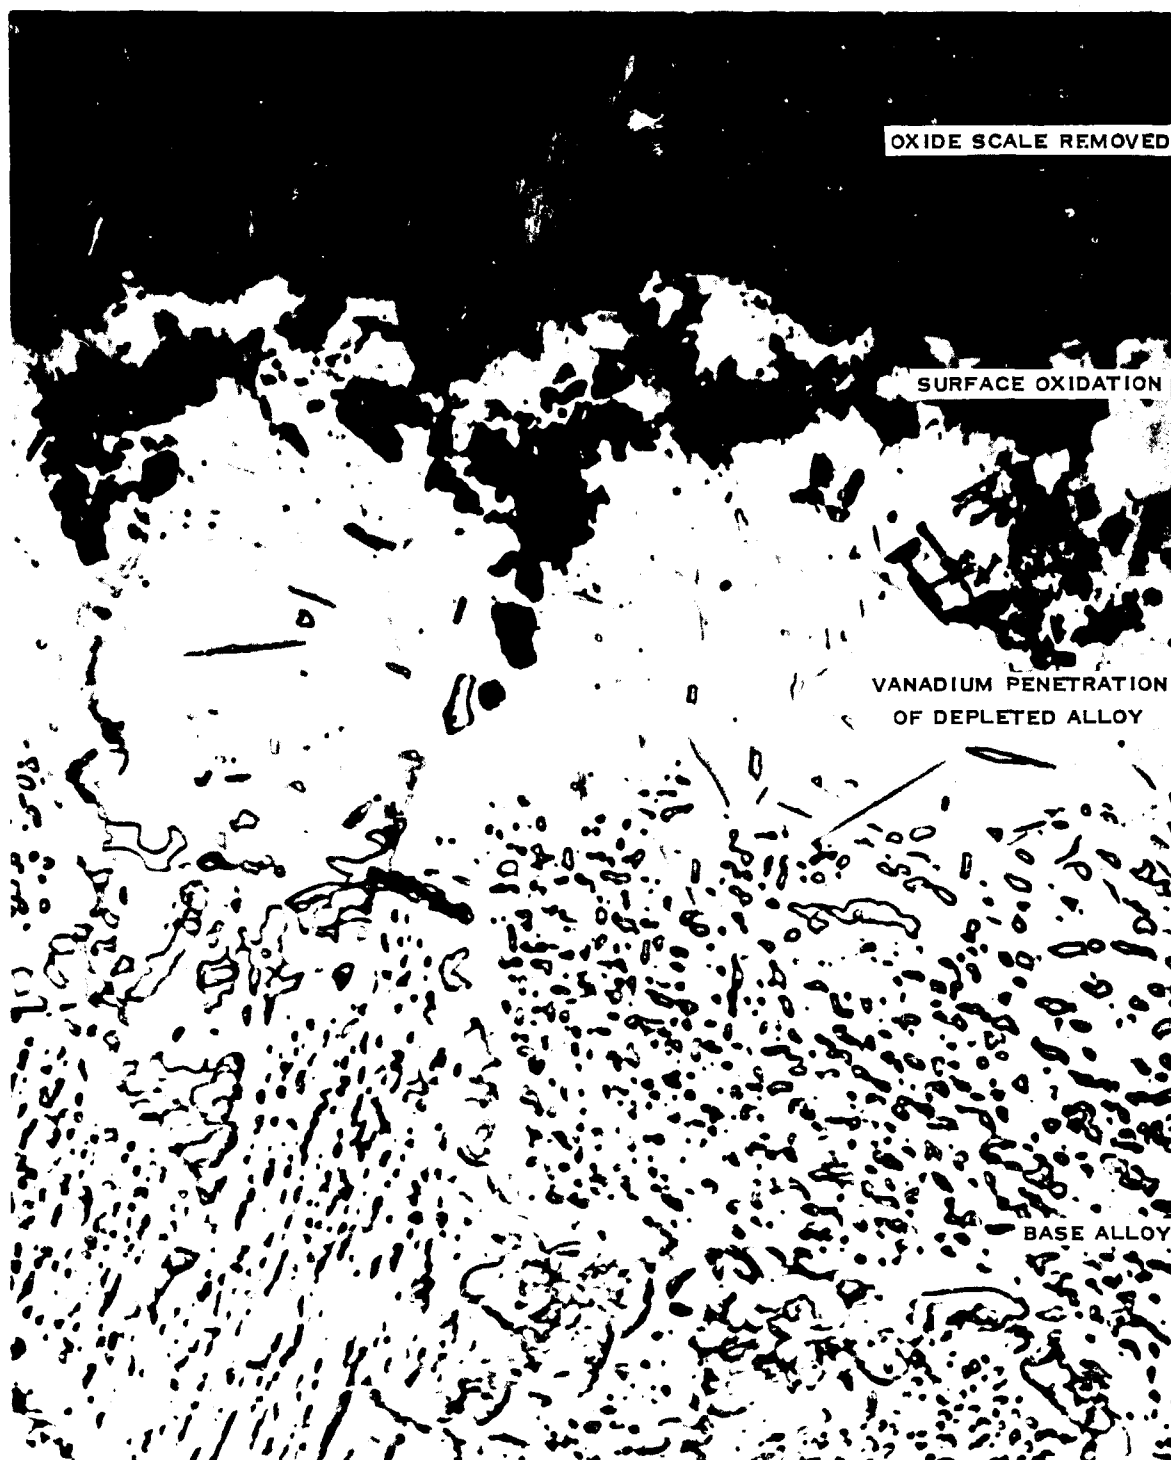
FIGURE 30
SURFACE OXIDATION WITH VANADIUM PENETRATION

METALLOGRAPHIC CROSS-SECTION OF INCONEL 713C SPECIMEN AFTER 55 HOURS AT 2000F TEST CONDITION WITH 0.017 PPM VANADIUM IN AIR. ELECTRO-CLEANED. MARBLE'S REAGENT ETCHED. 1000X MAGNIFICATION.

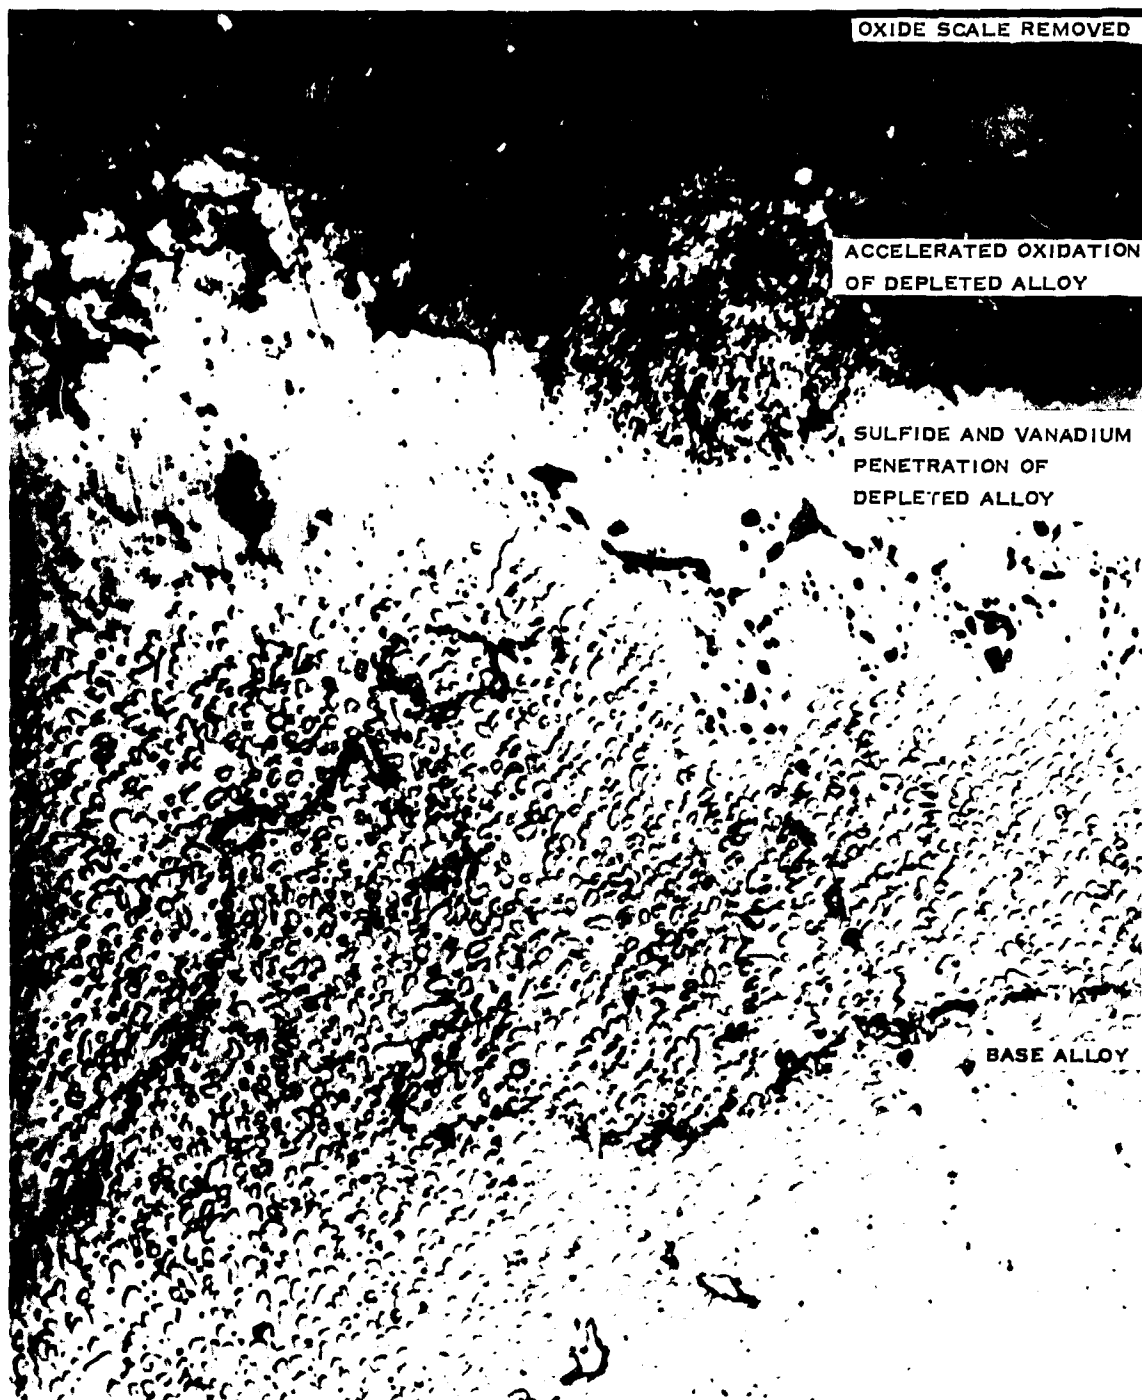
FIGURE 32
ACCELERATED SURFACE OXIDATION WITH VANADIUM PENETRATION

METALLOGRAPHIC CROSS-SECTION OF INCONEL 713C SPECIMEN AFTER 20 HOURS AT 2000F TEST CONDITION WITH 1.0 PPM SEA SALT AND 0.063 PPM VANADIUM IN AIR. ELECTRO-CLEANED. MARBLE'S REAGENT ETCHED. 1000X MAGNIFICATION.

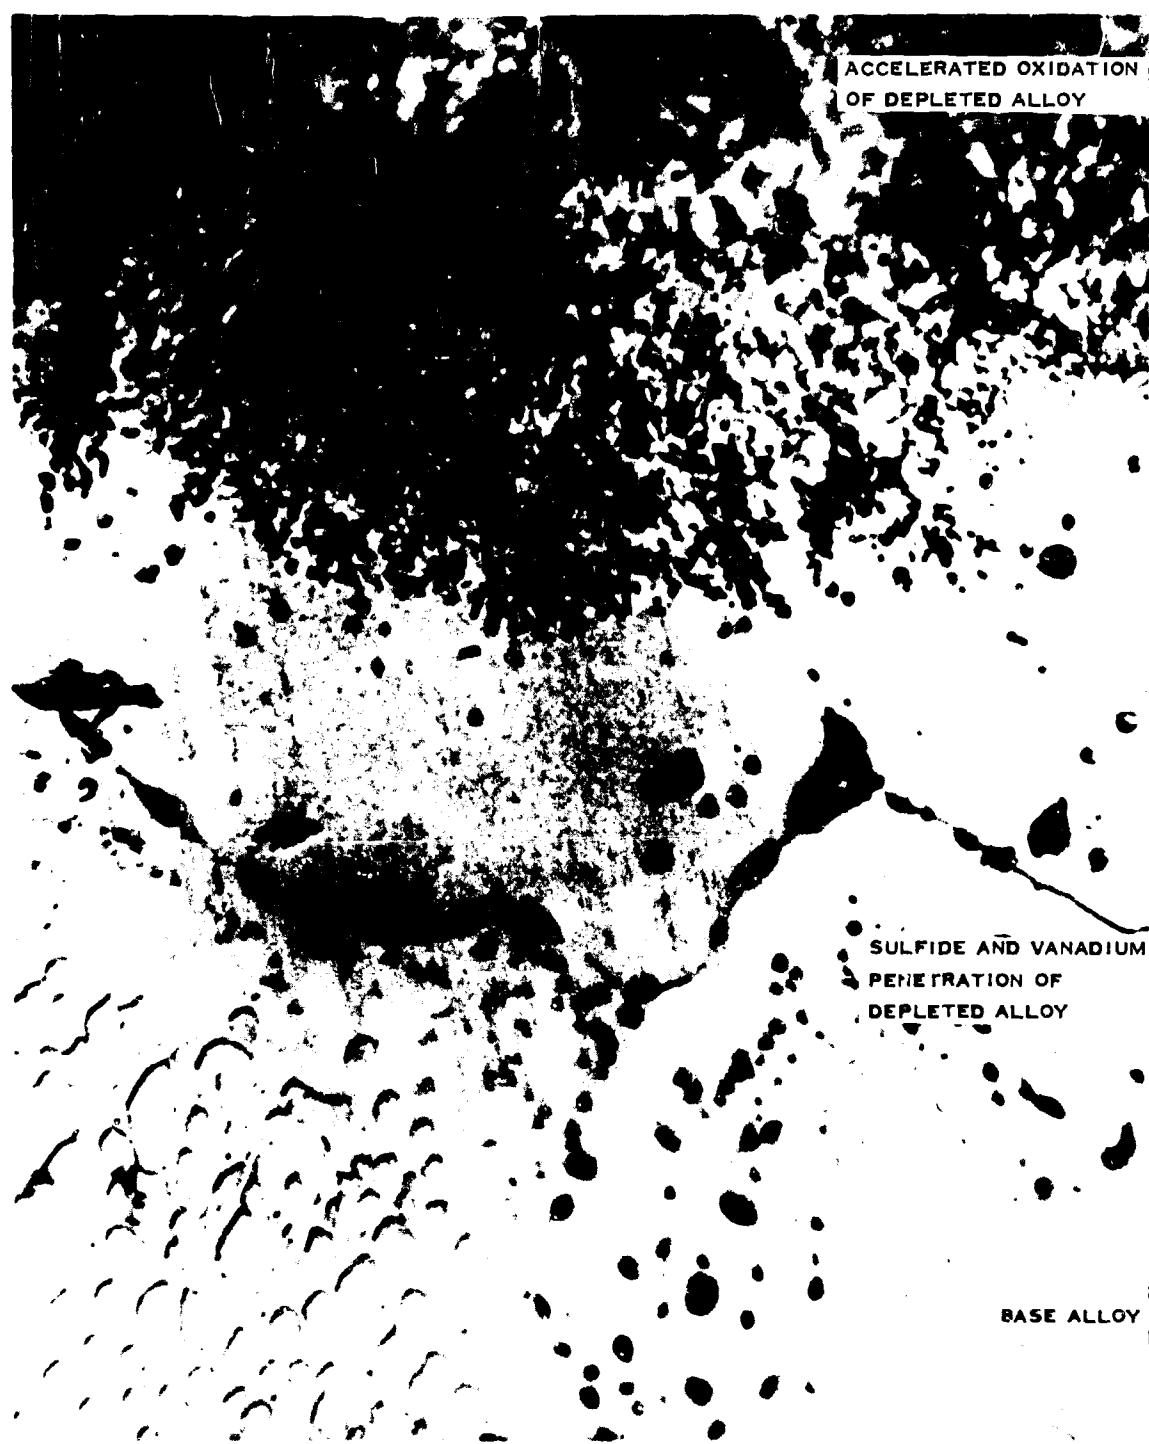
FIGURE 33
ACCELERATED SURFACE OXIDATION WITH VANADIUM PENETRATION

METALLOGRAPHIC CROSS-SECTION OF INCONEL 713C SPECIMEN AFTER 20 HOURS AT 2000F TEST CONDITION WITH 1.0 PPM SEA SALT AND 0.063 PPM VANADIUM IN AIR. ELECTRO-CLEANED. CARPELLA'S REAGENT ETCHED. 3000X MAGNIFICATION.

With the addition of vanadium to this sea-salt environment, the corrosion interface was modified by oxide penetration in the alloy-depleted zone, as shown in Figure 32. Thus, vanadium attack in the presence of sea salt appears to be similar to that previously shown in Figure 31 without sea salt. However, the depth of the layer of depleted alloy has been greatly reduced by the accelerated-oxidation attack with sea salt, previously shown in Figure 11. The corrosive effects of vanadium and sea salt appear to be additive, and evidence of both mechanisms can be seen more clearly at higher magnification in Figure 33.

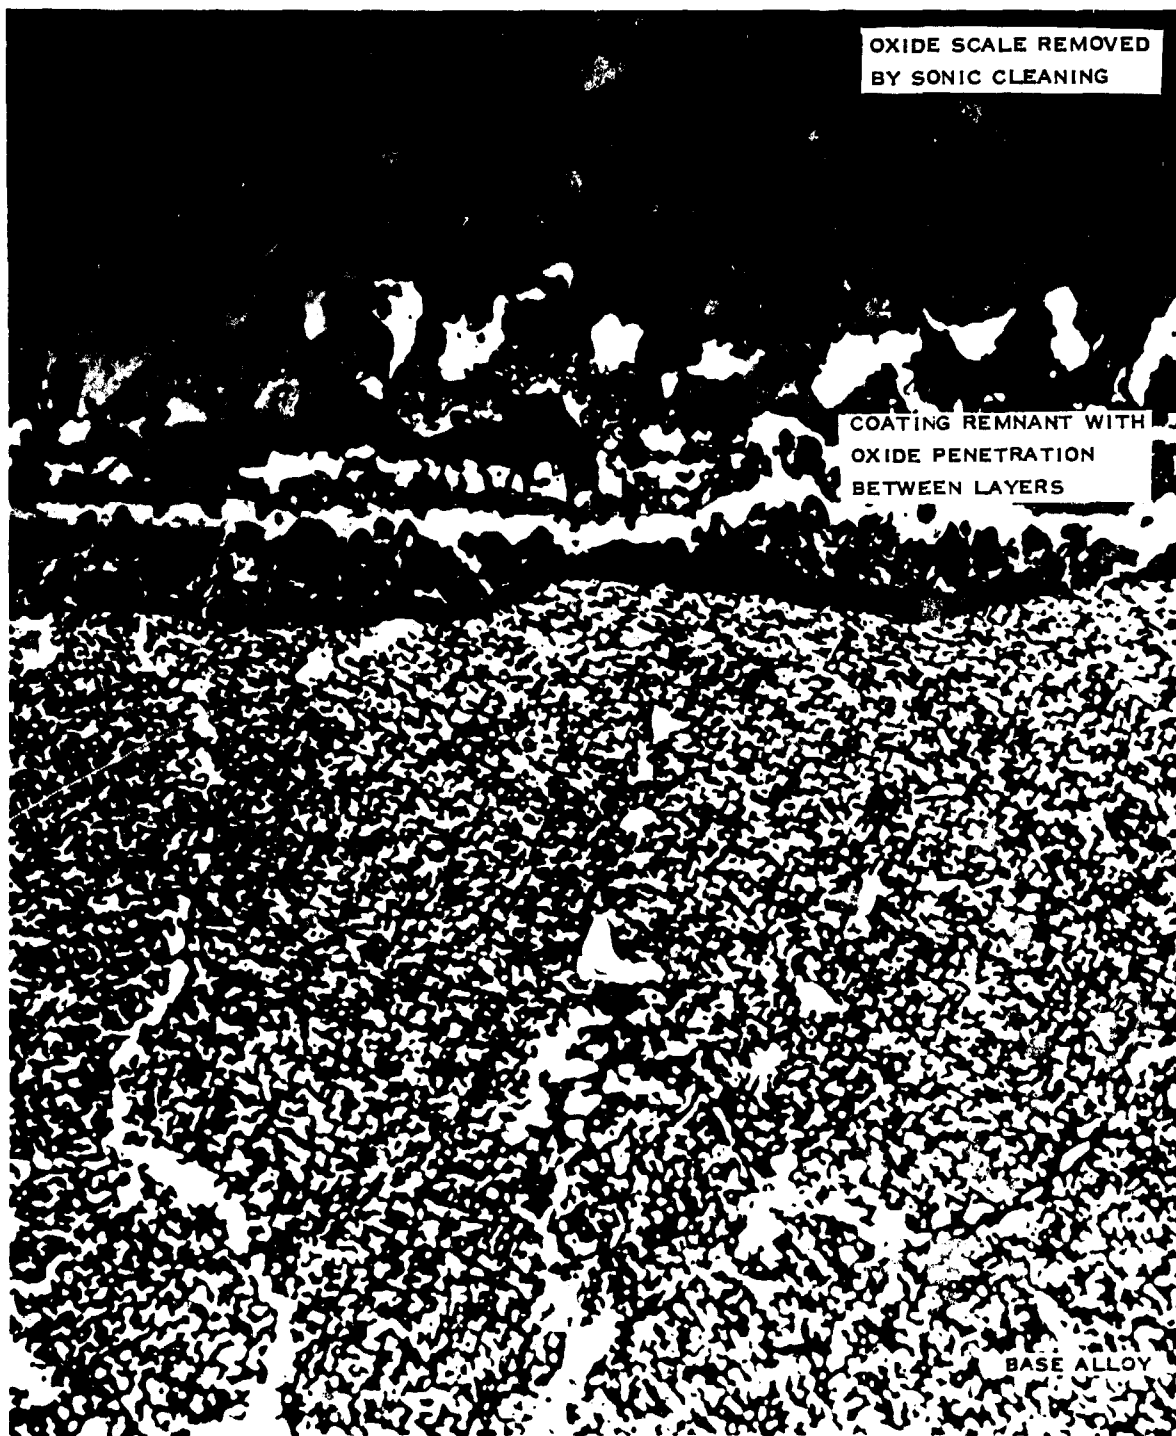
FIGURE 40
OXIDATION OF MISCO MDC-9 COATING ON INCONEL 713C SPECIMEN AT 1600 F

METALLOGRAPHIC CROSS-SECTION OF SPECIMEN AFTER 45 HOURS AT 1600 F TEST
CONDITION WITH 1.0 PPM SEA SALT IN AIR AND 0.40 WT % SULFUR IN FUEL.
3% SULFURIC ACID-ELECTROLYTIC ETCHED. 1000X MAGNIFICATION.

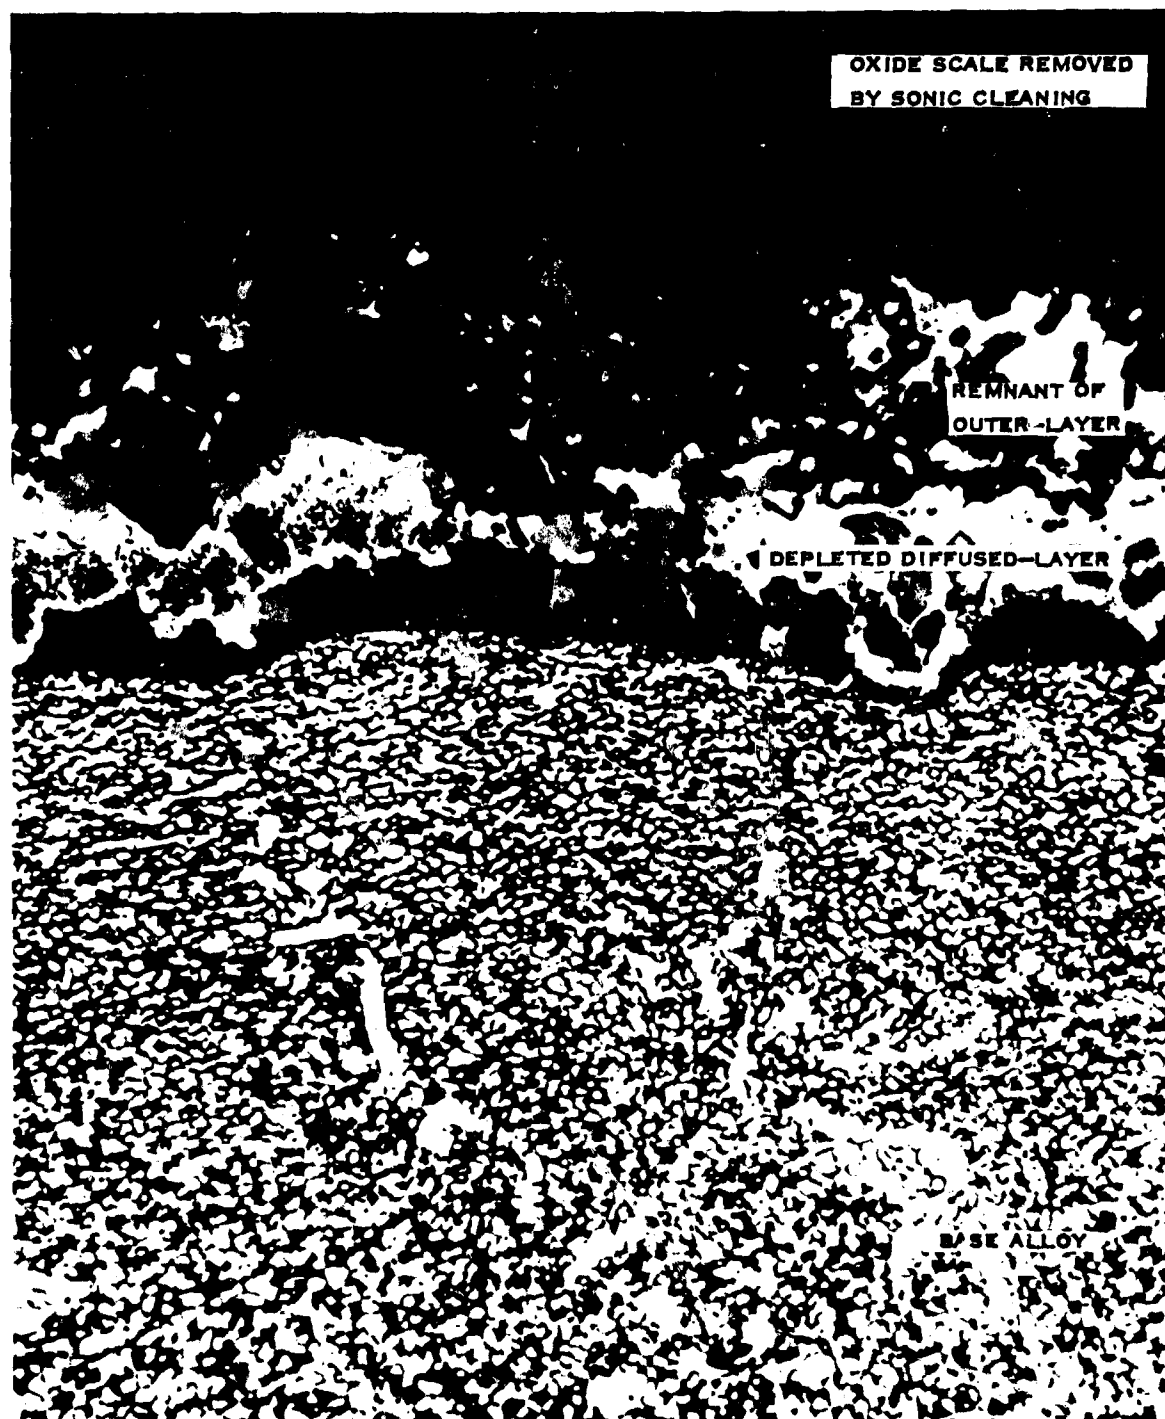
FIGURE 41
OXIDATION OF MISCO MDC-9 COATING ON INCONEL 713C SPECIMEN AT 1800 F

METALLOGRAPHIC CROSS-SECTION OF SPECIMEN AFTER 45 HOURS AT 1800 F TEST
CONDITION WITH 1.0 PPM SEA SALT IN AIR AND 0.40 WT % SULFUR IN FUEL,
3% SULFURIC ACID-ELECTROLYTIC ETCHED. 1000X MAGNIFICATION.
